RE: Progress report for September 2006 activities - Hecla Mining Company Apex Site (EPA ID No. UT982589848, Docket No. RCRA-8-99-06)

MEMORANDUM TO: Apex File
COPIES TO: distribution
FROM: Paul Glader *PG*
SUBJECT: **Progress Report No. 29 for period ending September 30, 2006; Pond 2 Final Closure - Apex Site, Washington County, Utah**

TO: Paul Glader (Hecla Mining Company)
FROM: Doug Gibbs (Monster Engineering Inc.)
DATE: 10/4/06
SUBJECT: **Surface Monument Survey Data Review – Apex Site**

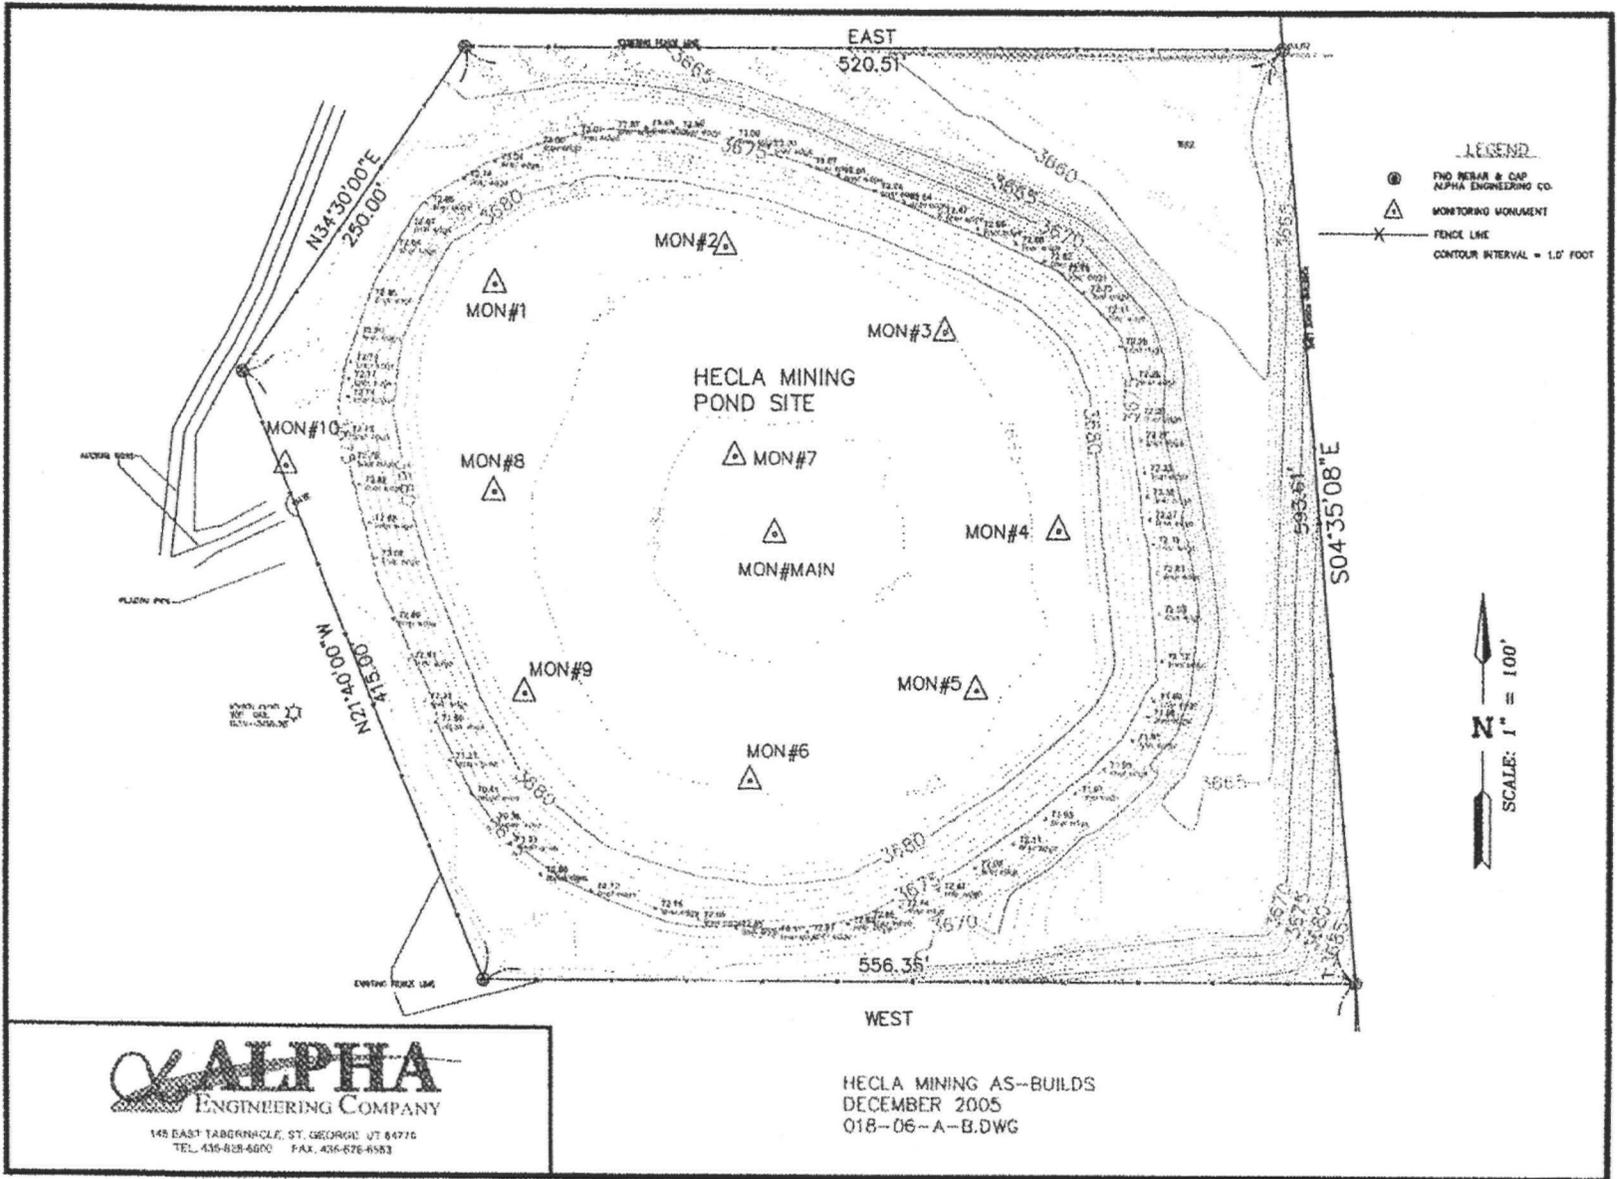
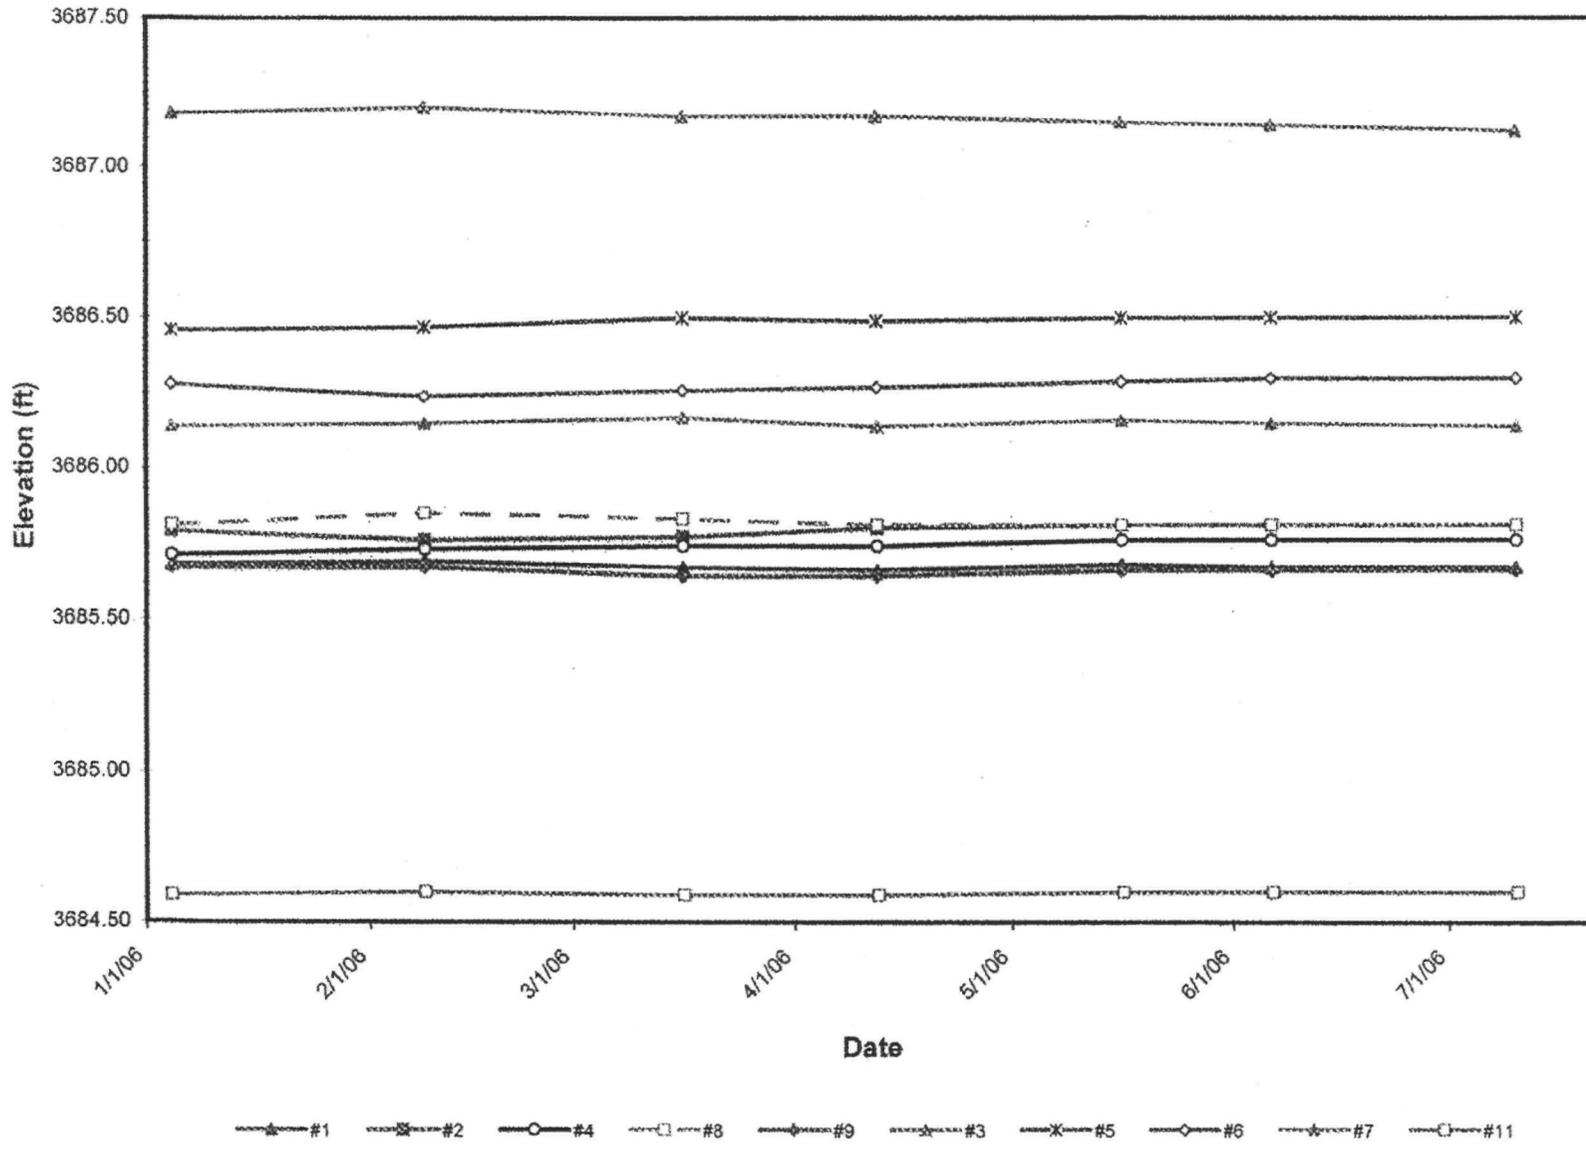
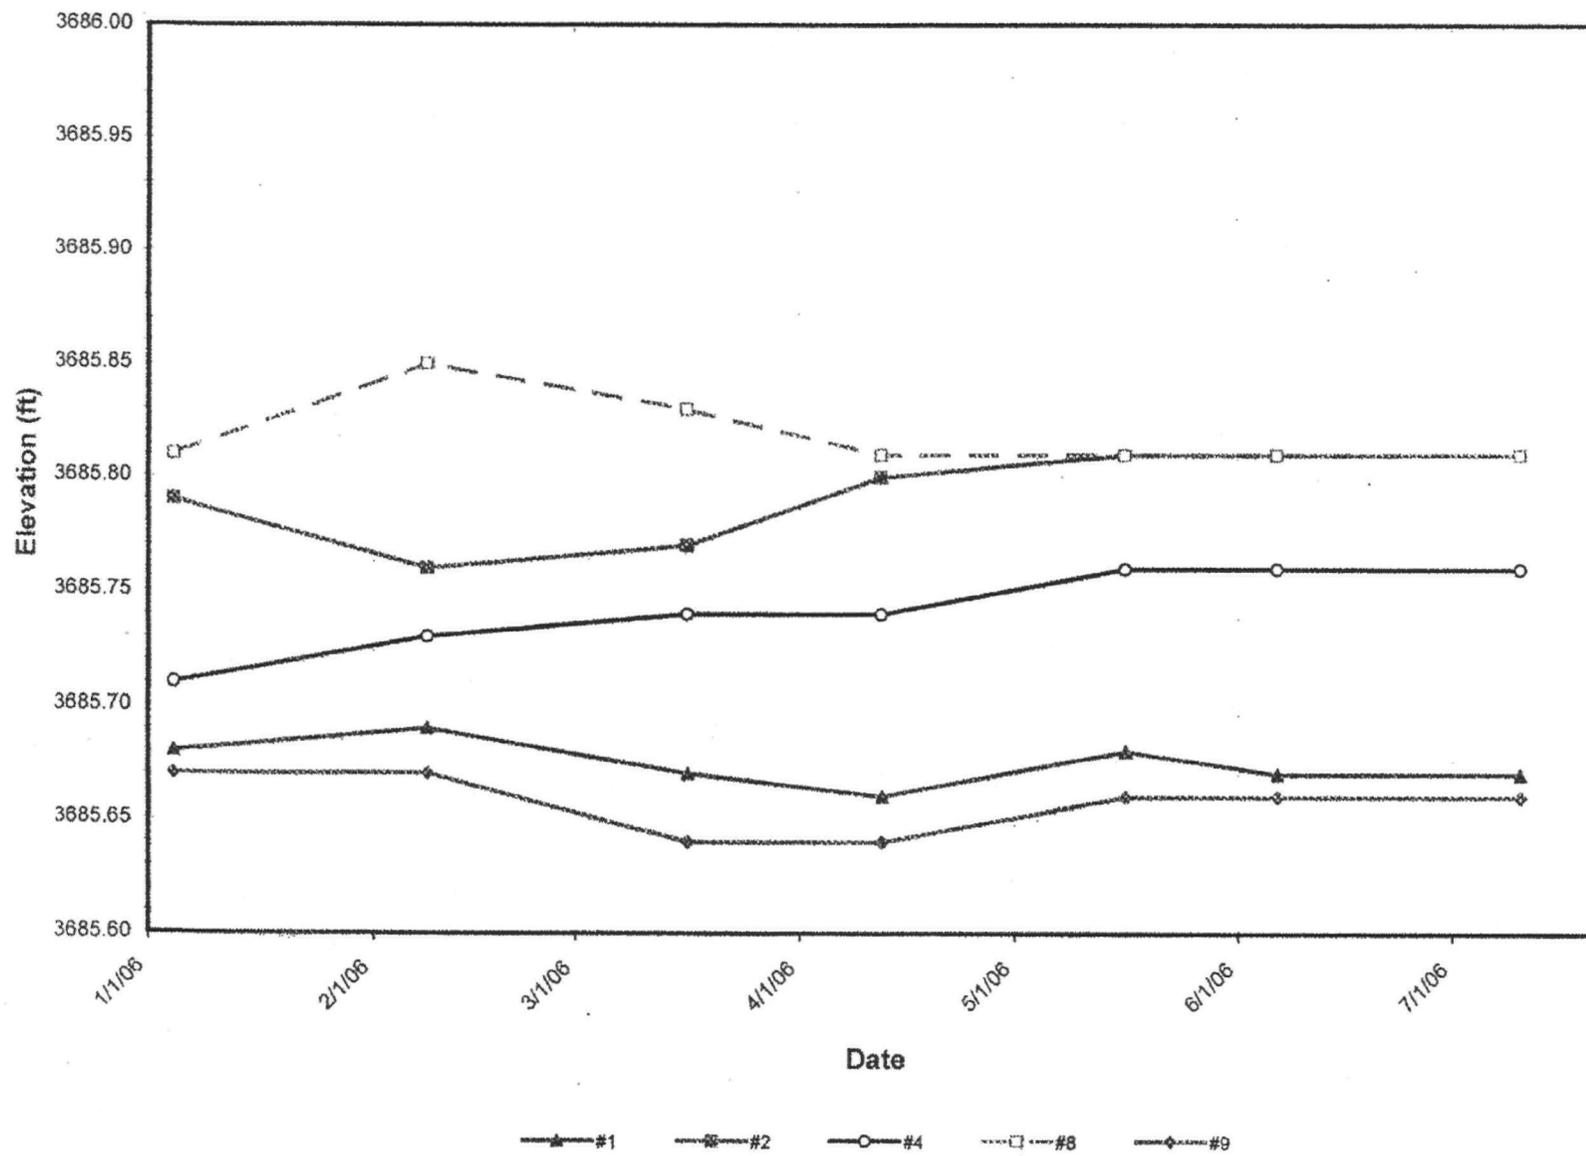
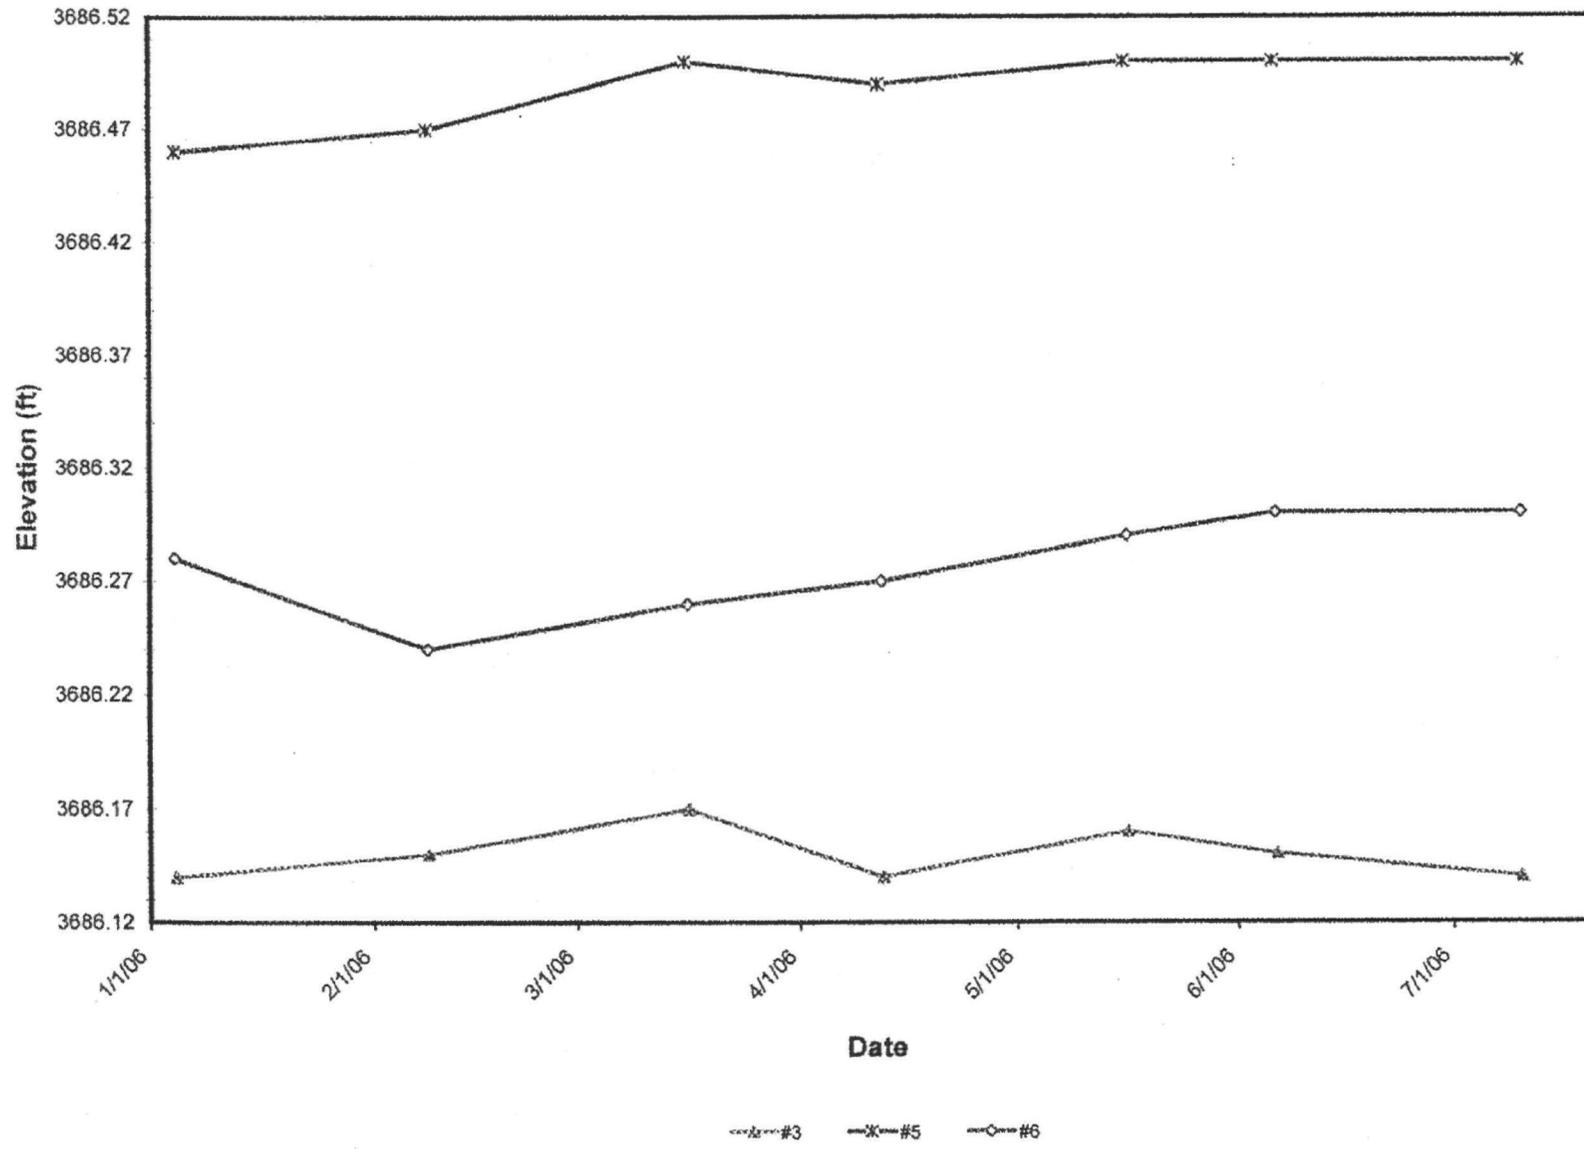
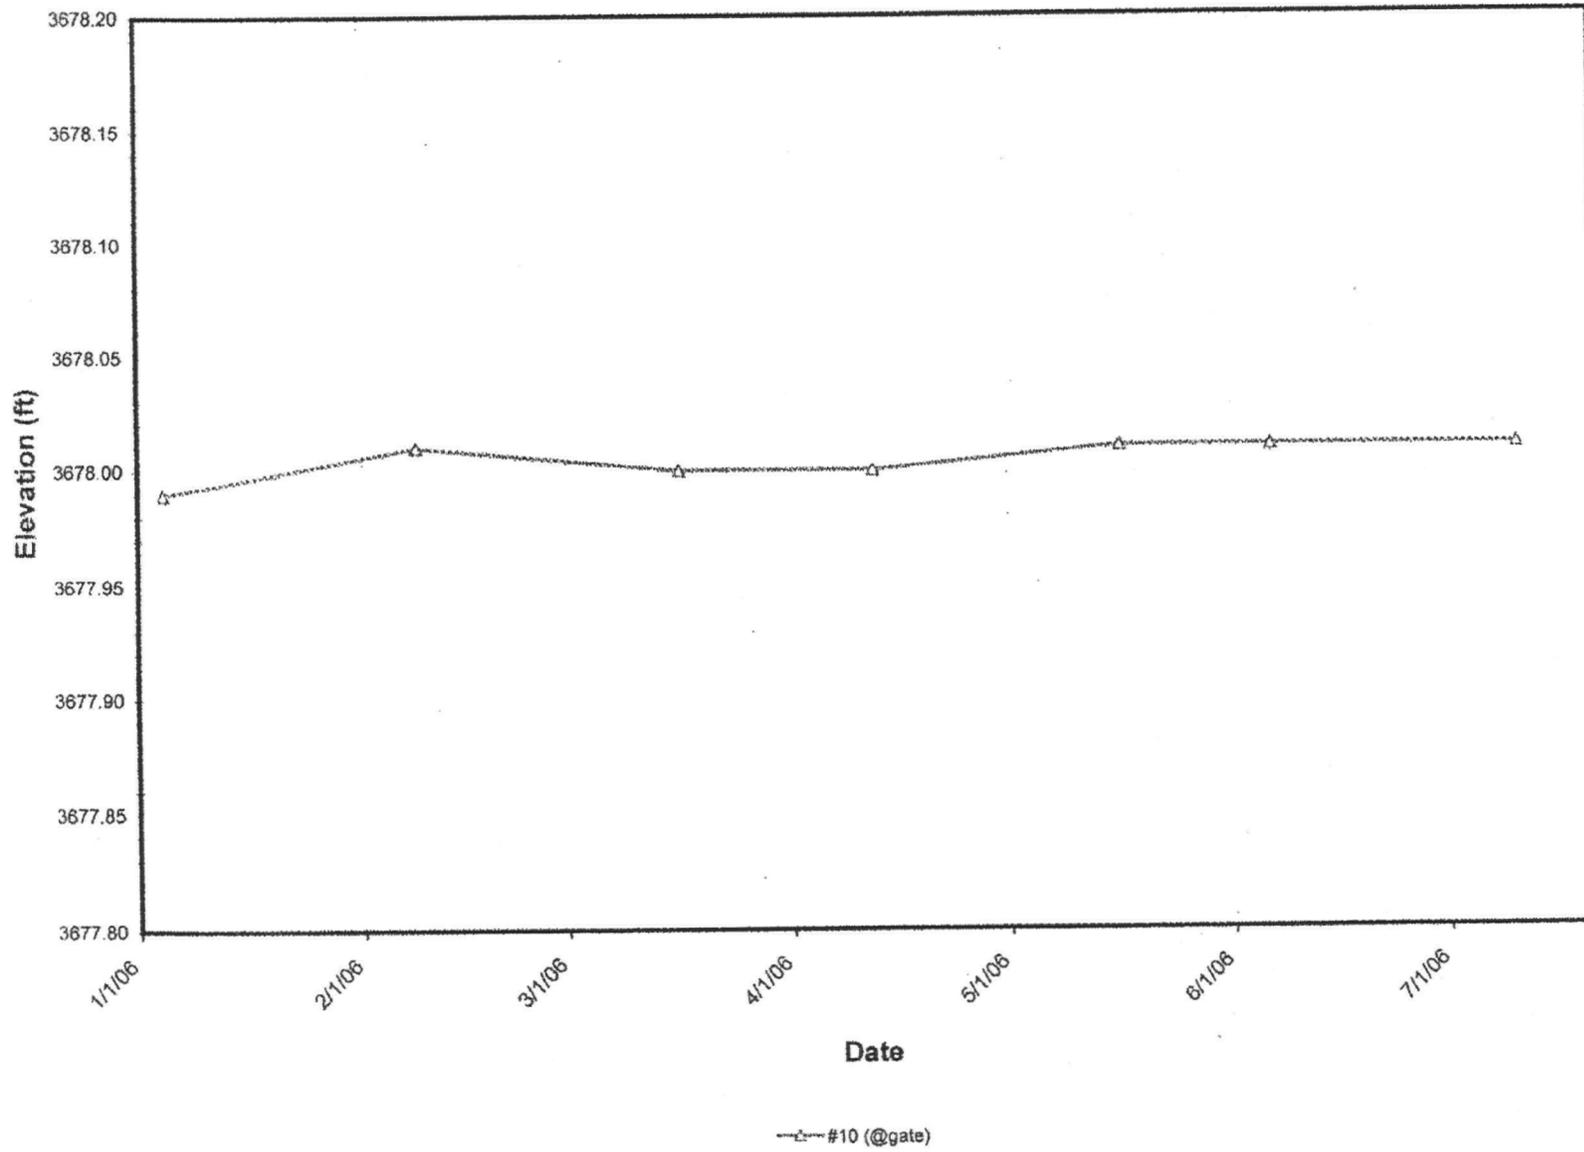
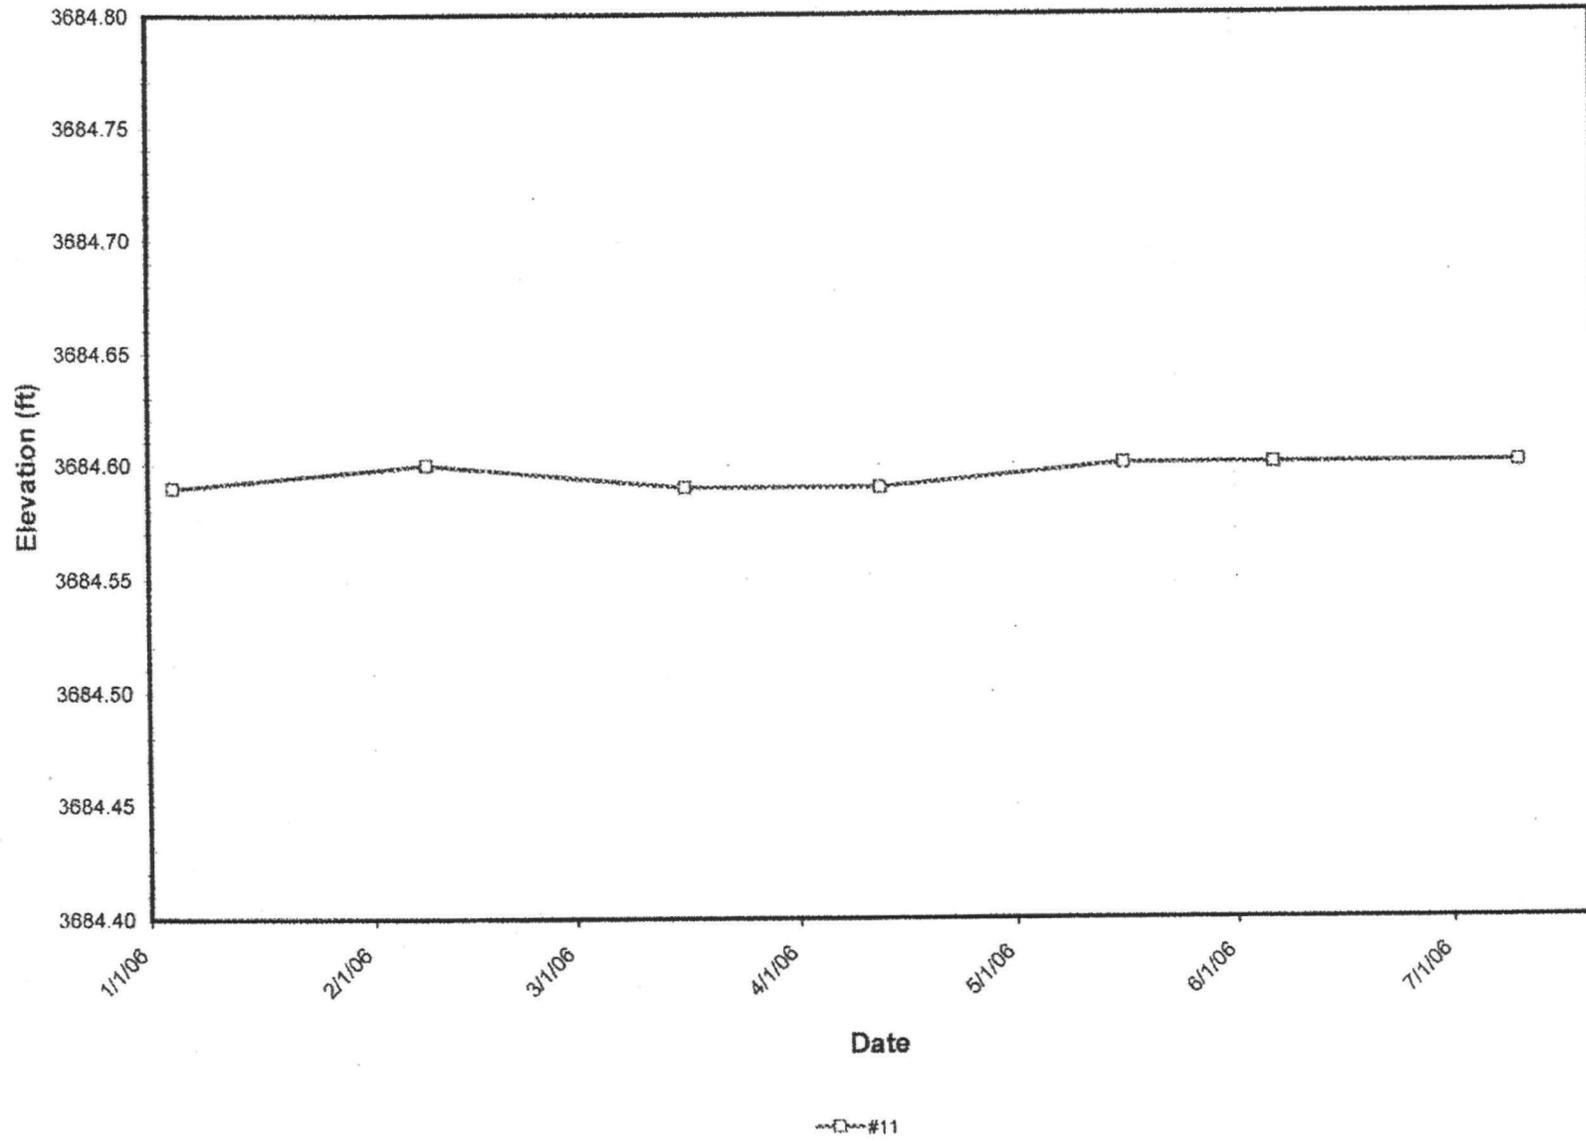
Apex Pond 2 - Settlement Monument Elevations

To date it appears that most apparent movement can be attributed to surveying accuracy limitations as monitoring data continues to show individual monuments both increasing and decreasing in elevation from monitoring period to monitoring period. Monument #7 (near the center of the impoundment) appears to be the only monument that has consistently decreased since February. Some settlement in this area nearer the center of the impoundment is not unexpected as significant quantities of fill were placed during construction. Total apparent settlement at monument #7 has been 0.06 feet (0.72 inches) in approximately 5 months. Conversely, the elevation for monument #11, which is located at the center, and high point of the impoundment, and very near monument #7, has been very consistent since installation. Monument #11 has moved a total of only +0.01 feet since installation.

Between the first monitoring period in January and the latest monitoring period (7/10/06), elevations of two monuments have not changed (#3 and #8), three have decreased (#1, #7, and #9), and five have increased (#2, #4, #5, #6, and #11) as shown in the table on the following page.

Based on data collected to date, MEI recommends that Hecla continue with their plan to decrease data collection frequency to quarterly. Please call or email me if you have any questions concerning this review.
